BMW Motorrad USA

Service Information Bulletin

****Notice of Recall 15V-141****

Subject: Wheel flange

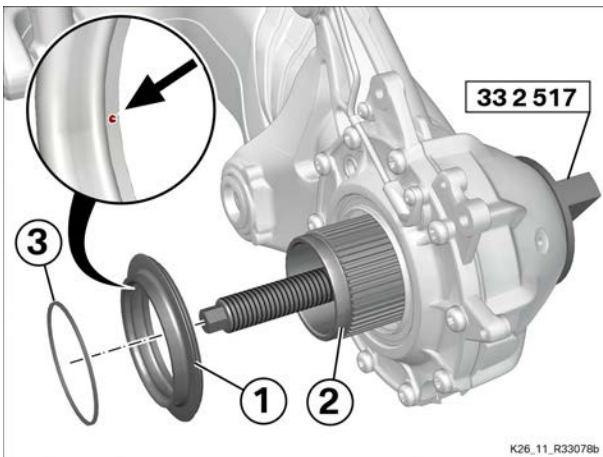
- Position spacing ring (1), noting the split pin (arrow).
- » The split pin (arrow) sits in splines of wheel axle (2).
- Installing spacer ring (1) making sure that it engages **perceptibly** and **with an audible click**.
- Install O-ring (3).
- Insert installation tool (33 2 517).

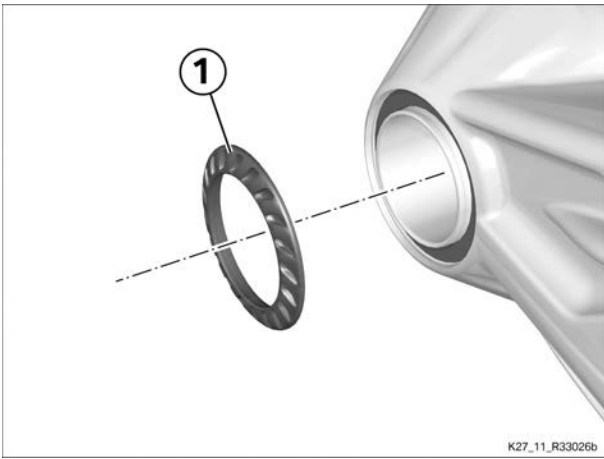
- Install cover **(1)**.

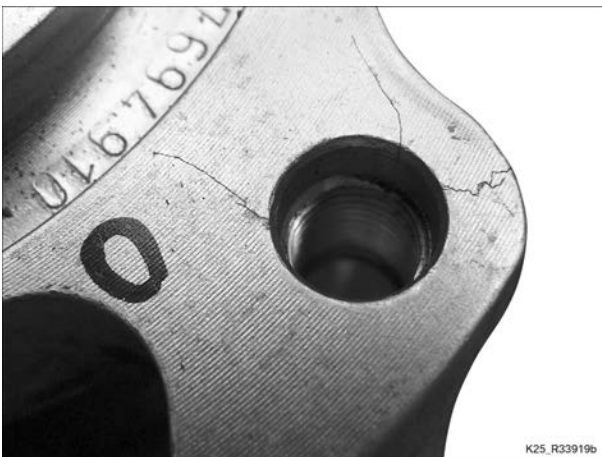
- Crack example 1

Number and appearance of the cracks in the wheel flange might vary and need not necessarily correspond to the images depicted.

- Wheel flange must be replaced.
